**Fire Resistance Test in Accordance  
with BS EN 1634-1: 2000, on a Horizontal  
Sliding, Accordion Type Doorset  
within a Partition**

**Won-Door Corporation**

**Report Issued** : 6<sup>th</sup> November 2001

**Date of Test** : 28<sup>th</sup> June 2001.

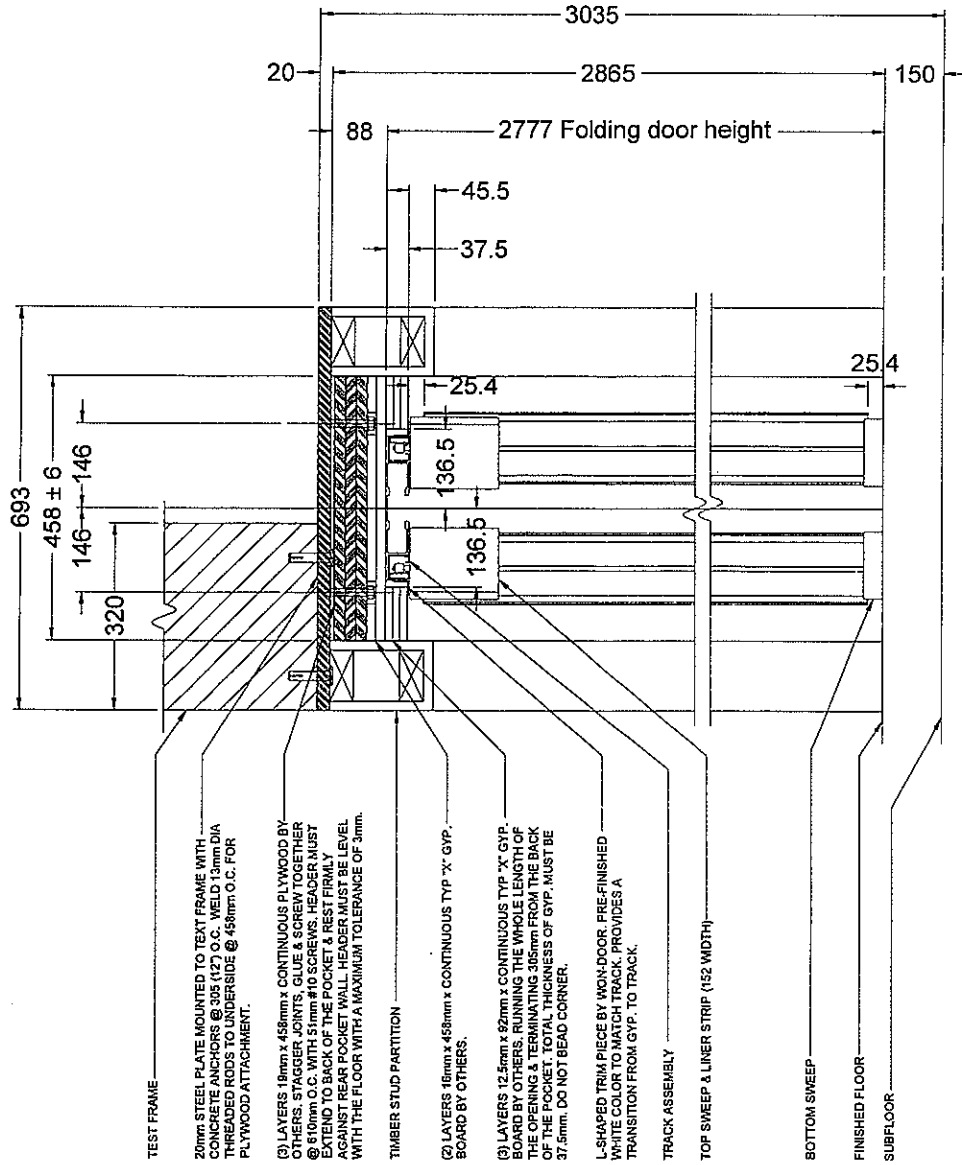
FIGURE 3

VERTICAL SECTION

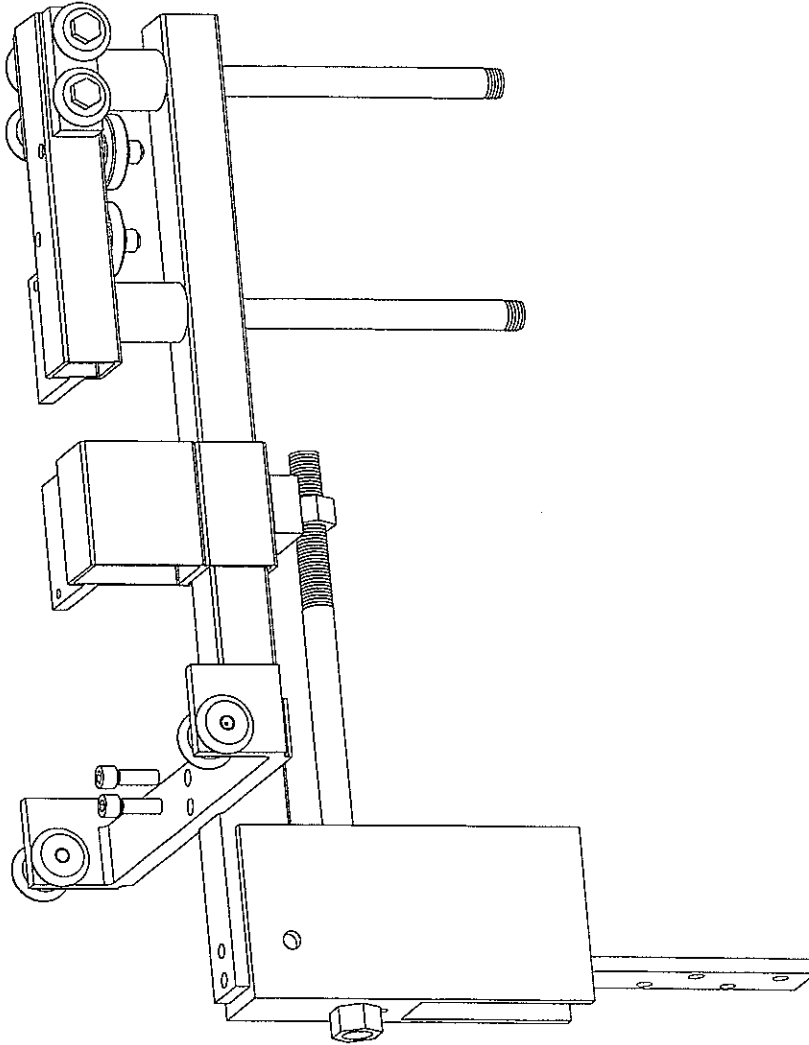
FIGURE 6

DETAIL OF T-05 OUTRIGGER  
TROLLEY ASSEMBLY

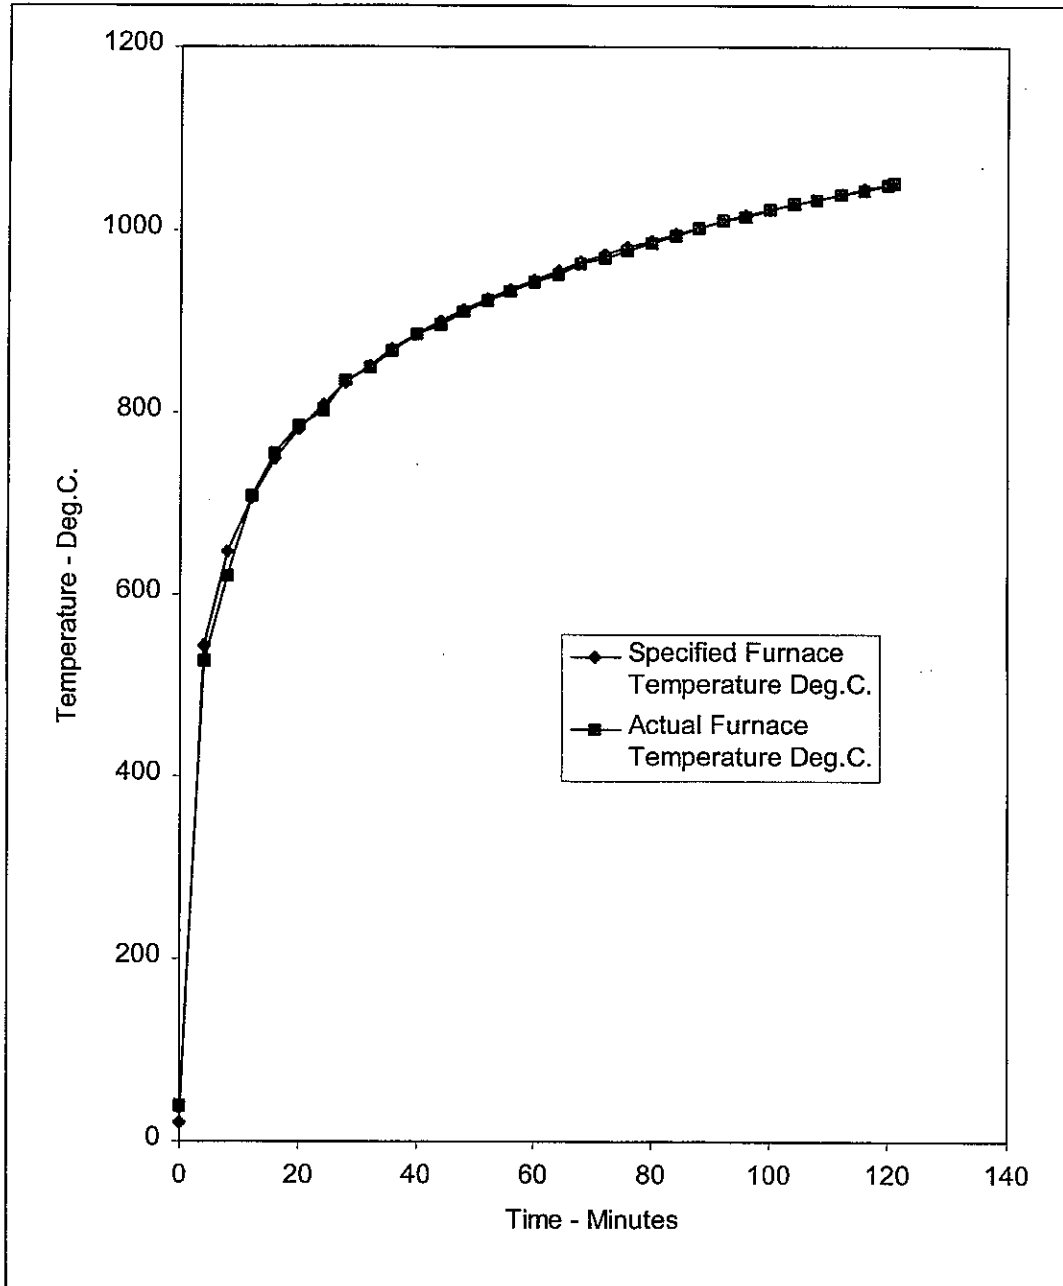
**Graph 1**

Specified and Actual Furnace Temperatures

Time Minutes	Specified Furnace Temperature Deg.C.	Actual Furnace Temperature Deg.C.
0	20	39
4	544	527
8	645	619
12	705	707
16	748	754
20	781	784
24	809	802
28	832	835
32	851	849
36	869	866
40	885	886
44	899	895
48	912	909
52	924	921
56	935	932
60	945	942
64	955	951
68	964	963
72	973	970
76	981	977
80	988	986
84	996	994
88	1003	1001
92	1009	1009
96	1016	1013
100	1022	1022
104	1028	1028
108	1033	1033
112	1039	1038
116	1044	1042
120	1049	1049
121	1050	1050

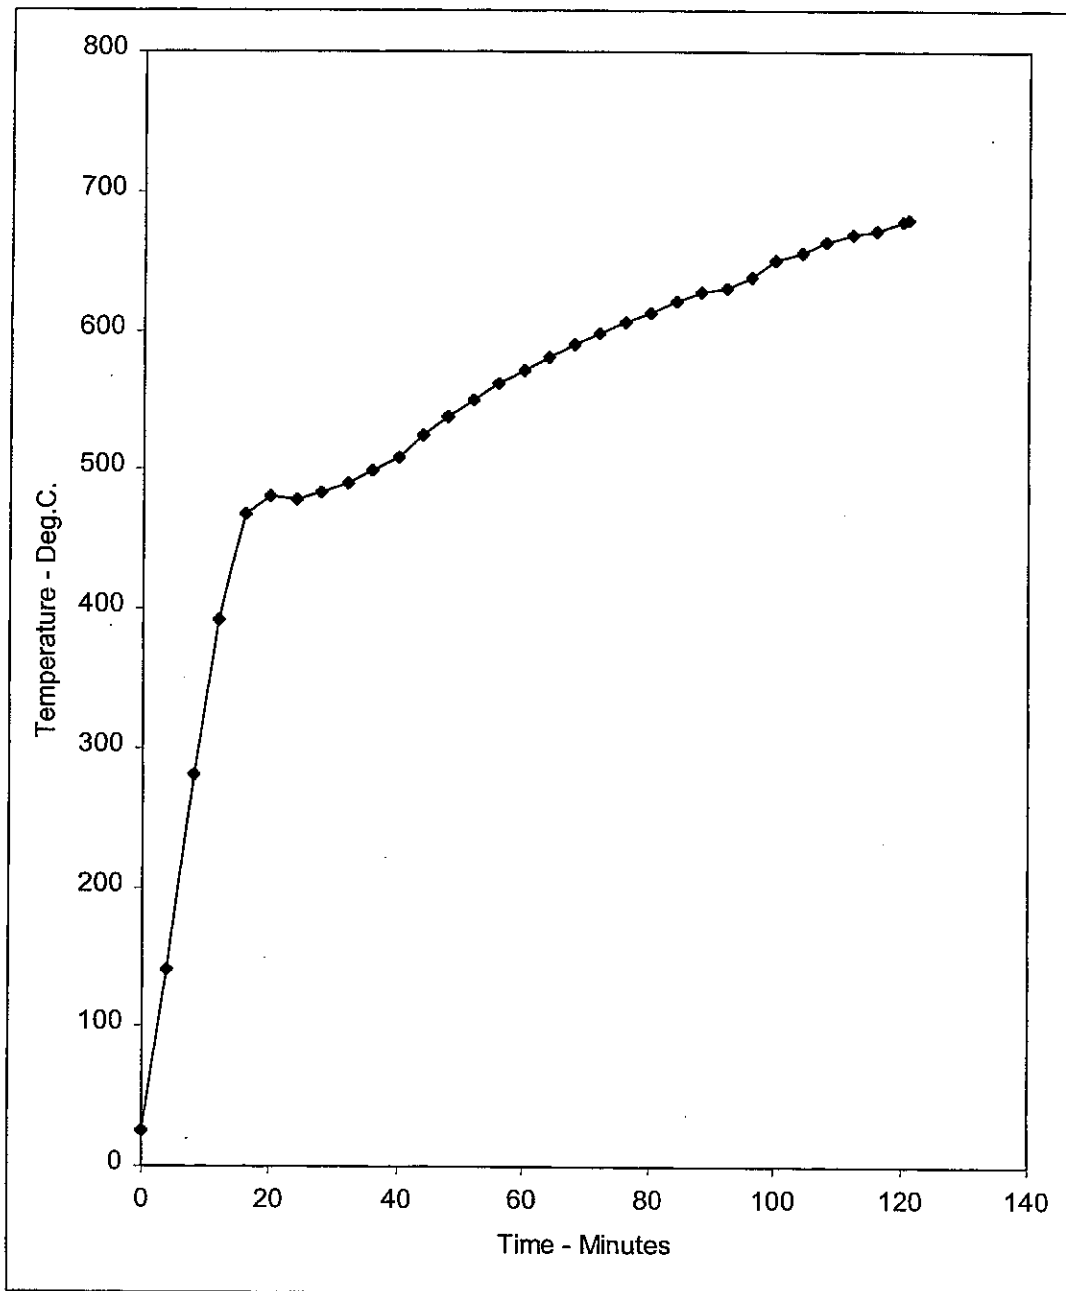
Graph 2

Mean Unexposed Surface Temperature Recorded on Doorset

Time Minutes	T/C Number 2 Deg.C.	T/C Number 3 Deg.C.	T/C Number 4 Deg.C.	T/C Number 5 Deg.C.	T/C Number 6 Deg.C.	Mean Temperature Deg.C
0	25	25	26	25	25	25
4	154	163	142	120	120	140
8	300	305	287	249	266	281
12	419	416	400	353	374	392
16	477	481	474	432	473	467
20	484	483	477	473	481	480
24	479	486	469	475	478	477
28	485	495	477	473	487	483
32	498	501	481	477	491	490
36	509	508	488	486	501	498
40	523	517	495	498	509	508
44	543	531	511	513	522	524
48	557	546	525	526	534	538
52	569	560	536	539	545	550
56	581	572	547	553	558	562
60	588	583	557	561	568	571
64	596	591	566	570	579	580
68	606	601	574	579	589	590
72	614	609	581	587	598	598
76	623	617	588	596	606	606
80	630	624	594	603	614	613
84	639	633	601	612	621	621
88	646	639	608	621	623	627
92	650	640	611	626	623	630
96	663	645	616	638	626	638
100	679	656	629	653	634	650
104	682	662	633	663	639	656
108	685	669	642	672	648	663
112	690	674	649	679	653	669
116	688	675	650	686	658	671

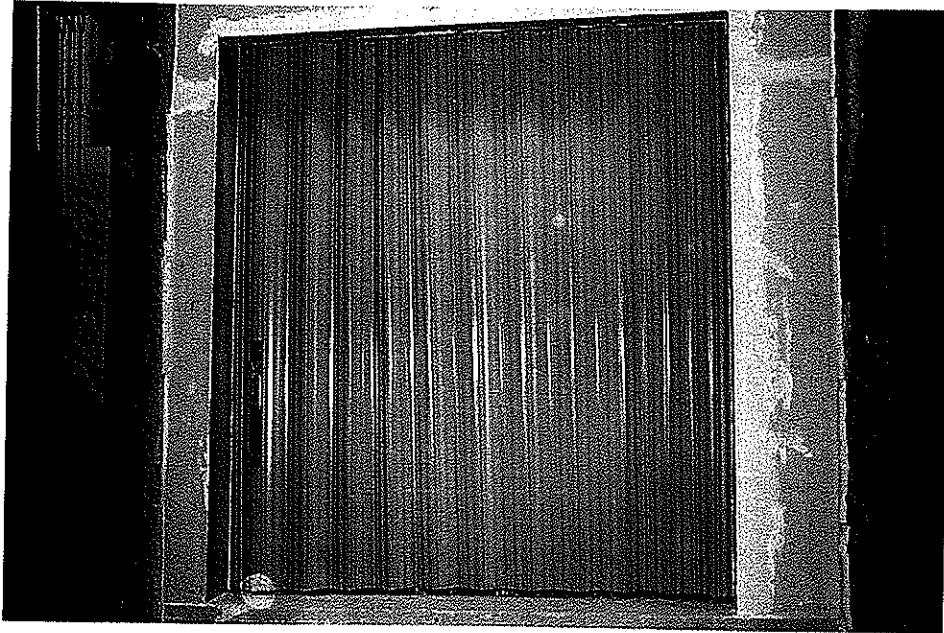
- Plate 1 - The exposed face of the specimen before the test
- Plate 2 - The unexposed face of the specimen before the test.
- Plate 3 - The unexposed face of the specimen during the test.
- Plate 4 - The unexposed face of the specimen during the test.
- Plate 5 - The unexposed face of the specimen during the test.
- Plate 6 - The unexposed face of the specimen during the test.
- Plate 7 - The unexposed face of the specimen during the test.
- Plate 8 - The unexposed face of the specimen during the test.
- Plate 9 - The exposed face of the specimen after the test.
